# CPO CERTIFIED PRE-OWNED HOME

**9524 Rhode Island Ave,  
College Park, MD 20740**  
***Table of Contents***

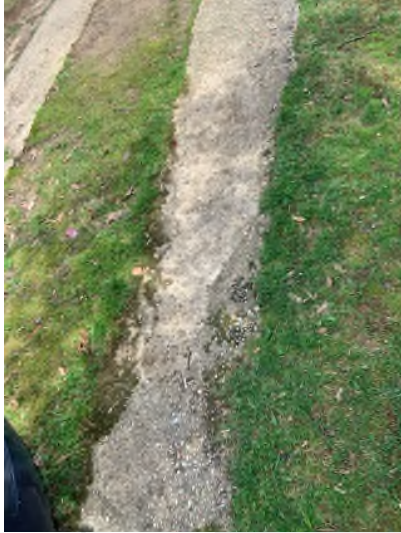
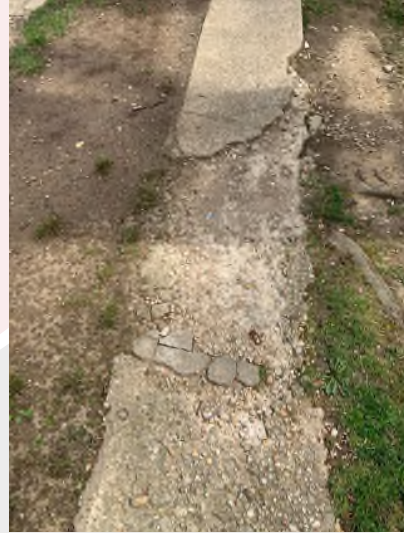
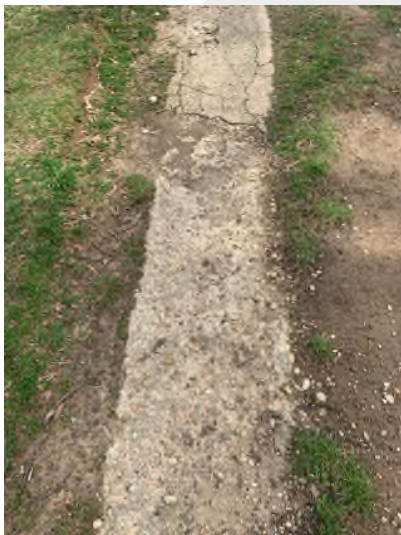
- Uneven slabs at the walkway. This is a potential tripping hazard. Recommend repair and or replacement of the displaced walks.
- There are numerous areas of damaged concrete surfaces. Recommend a concrete specialist provide an estimate for repair and or replacing.

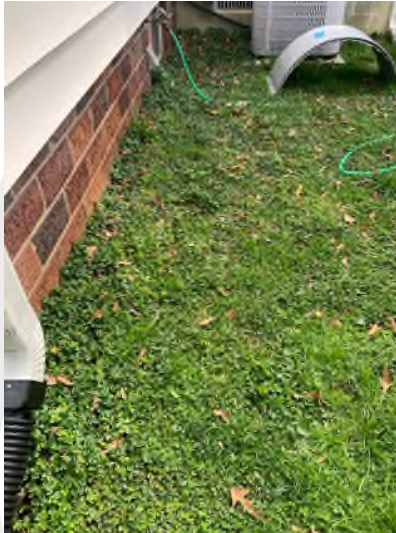
REPAIRED

- There are some low spots along the foundation.

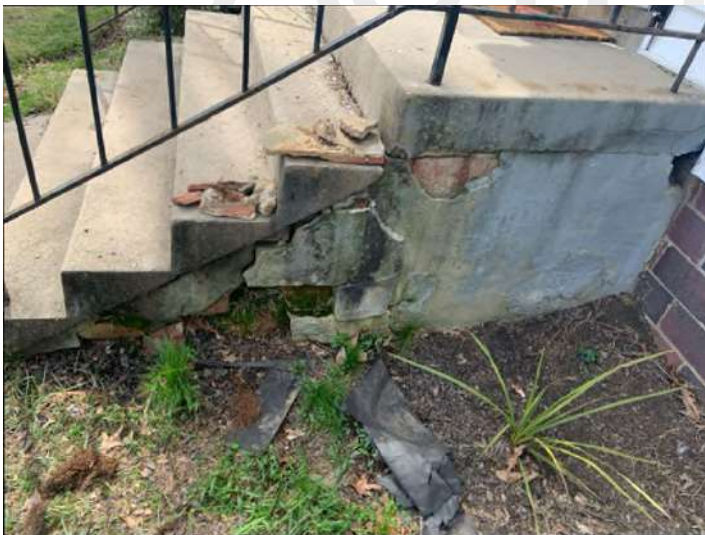
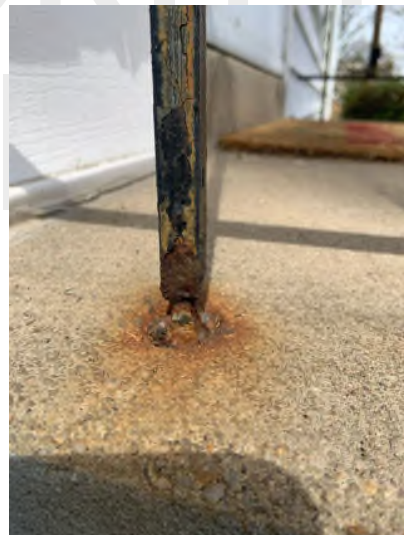
Observations:  
 • There is some deteriorated mortar noted. Recommend pointing as necessary.  
 • Guardrail post is rusted and close to the end of its life. Recommend having licensed contractor evaluate and repair as needed.

Guardrail pole rusting out

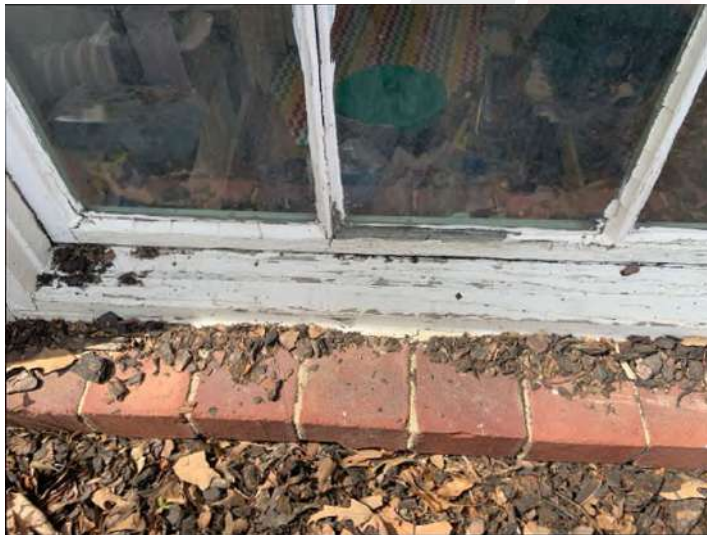
Front left basement window

Observations:  
 • Broken glazing observed, suggest re-glazing as necessary.  
 • Deterioration of window frames noted. While basic maintenance may prolong the life of these window frames, replacement may be necessary at some point.

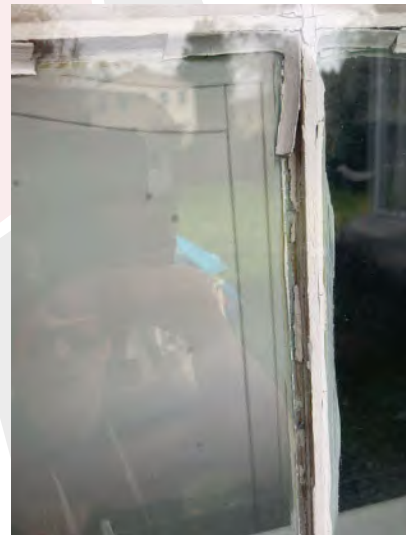
Glazing deteriorated

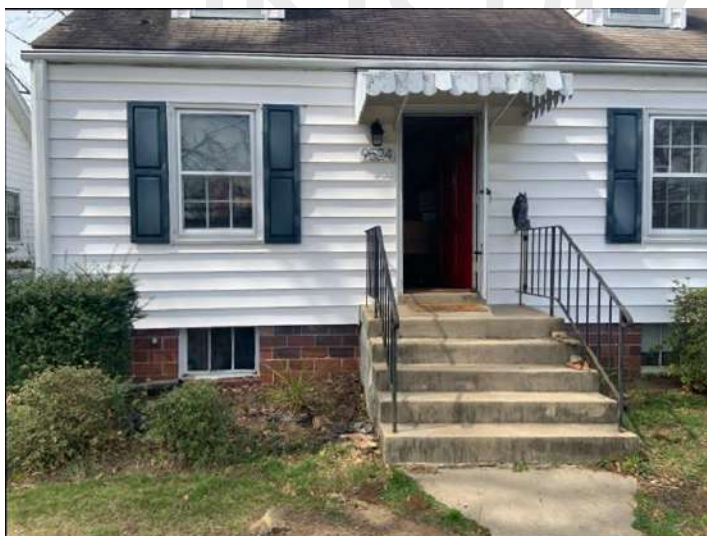
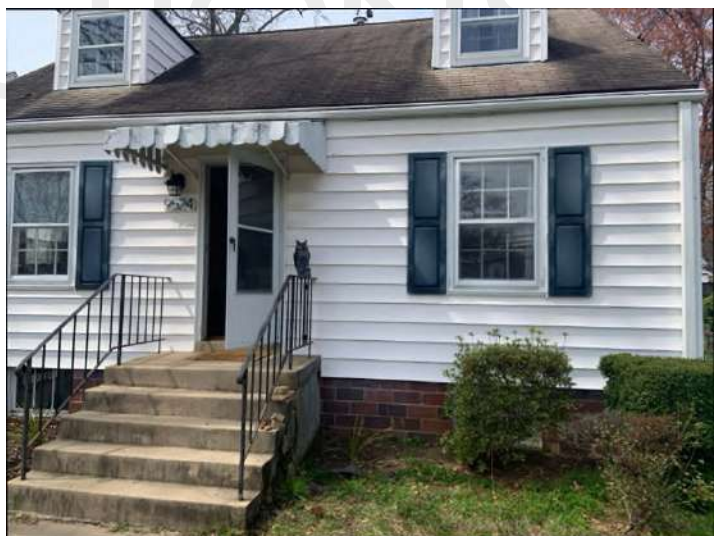
• Siding damage noted. Recommend repair or replacement of damaged sections to keep moisture and insects from harming structure.

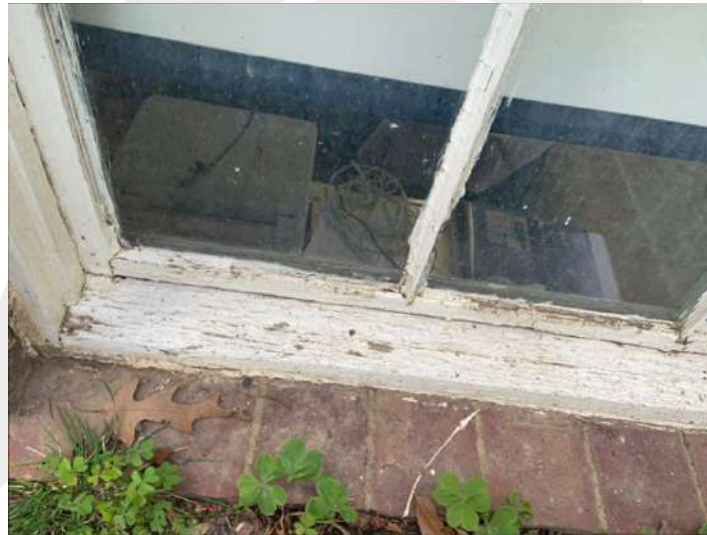
Basement windows

- Peeling paint observed, suggest scraping and painting as necessary.
- Maintenance tip: All exterior painted wood trim surfaces should be bi-annually examined and sealed, re-caulked and re-painted as needed.
- Exposed wood surfaces observed. Wood rot & deterioration can occur. Prep, prime and paint wood trim surface where paint is peeling or missing.

REPAIRED

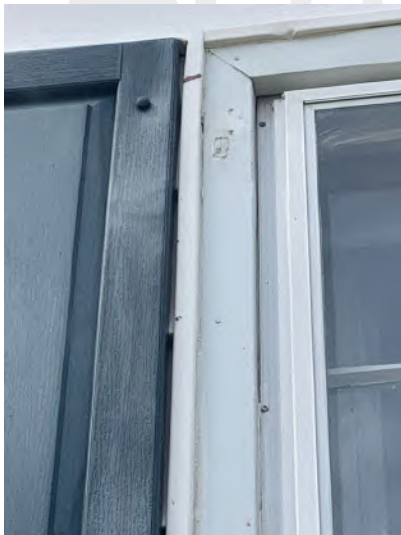
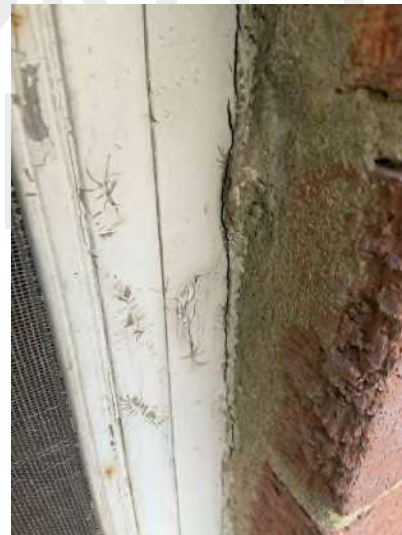
- Maintenance tip: Exterior caulking should be reviewed on a bi-annual basis and reapplied as necessary.
- Caulking around several windows and doors is beginning to deteriorate. Suggest caulking around windows and doors as necessary.

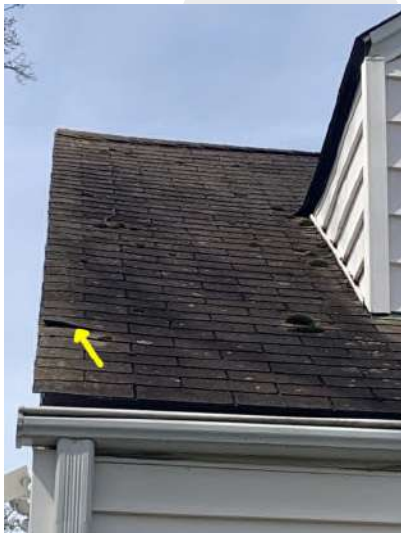
Unbonded

- **Some shingles missing.**
- Due to the conditions of the roof covering, we recommend evaluation by a professional roofing contractor for repair and certification as necessary.
- There are several shingles on roof covering that do not appear to be bonded properly. These may have to be hand sealed to prevent coming loose during high winds. Recommend evaluation by a professional roofing contractor for repair as necessary.
- Moss on roof. This can lead to the premature failure of the roof and subsequent leaks. Recommend treating moss during its growing season (wet months) with a moss killer. For information on various moss treatment products and their pros and cons, visit <http://bryophytes.science.oregonstate.edu/page24.htm>.

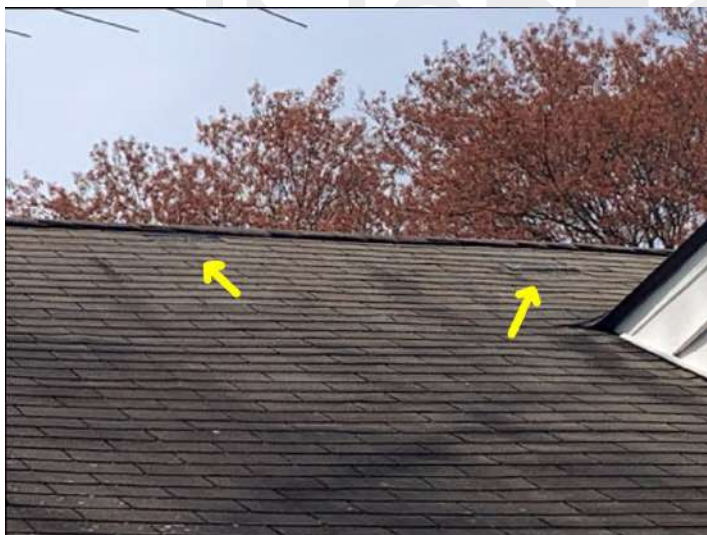
Missing

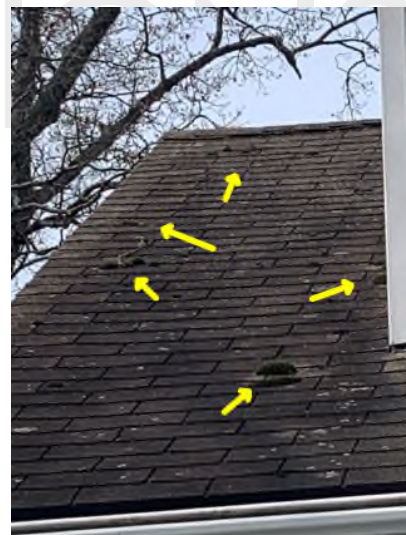
Moss

REPAIRED

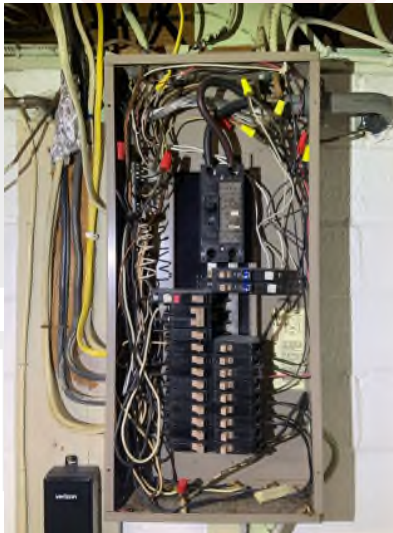
REPAIRED

• Aluminum wiring present—Between 1965 and 1973, aluminum wiring was sometimes substituted for copper wiring in residential electrical systems. Connections in outlets, switches, and light fixtures with aluminum wiring become increasingly dangerous as time passes. Poor connections cause wiring to spark and overheat, creating a potential fire hazard. The wiring should be evaluated by a qualified electrician experienced in evaluating and correcting aluminum wiring problems. Not all electrical contractors qualify. Aluminum wiring connections are subject to greater deterioration than is copper due to thermal expansion and contraction, vibration (caused when electric currents pass through wiring), oxidation (caused by exposure to oxygen in the air), and galvanic corrosion (caused when two different metals are connected together), all of which can cause poor connections. When wires are poorly connected they overheat, which creates a potential fire hazard.

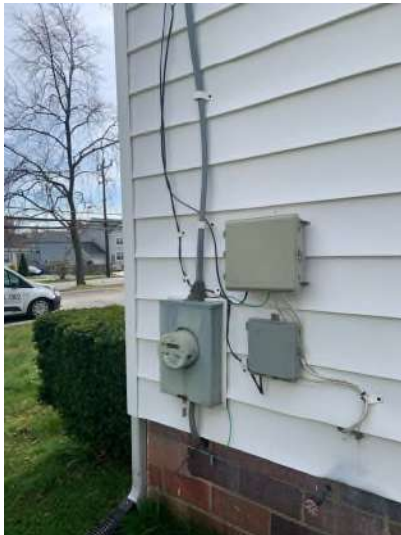
• There is an overhead service drop noted.

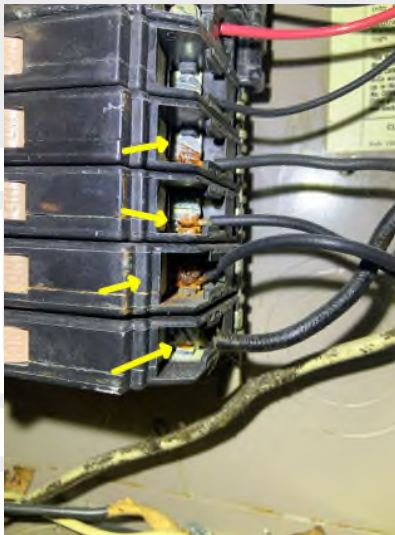
- Breaker contacts have rust on them. Recommend having licensed electrician evaluate and repair as needed

Rusty contacts

**REPAIRED**

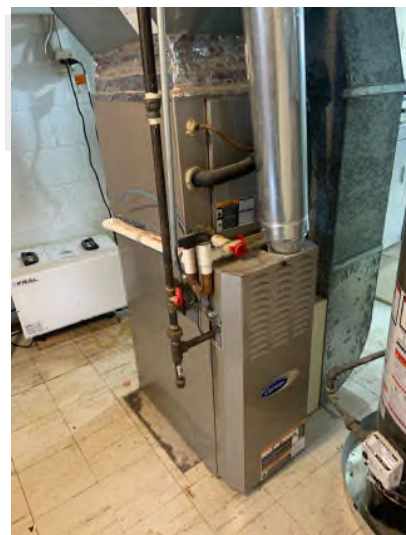
• Fuel Furnace: Last service date is over one year ago, or is unable to be determined. There are areas which cannot be seen without specialized equipment and training. One such area is the combustion chamber / heat exchanger where cold air blows across the "fire box", becoming the hot air that circulates throughout your home. During the life span of any furnace, this metal wall may develop a crack or a broken weld, allowing carbon monoxide to circulate throughout the home. This is why furnace specialists recommend a complete inspection annually; recommend having unit inspected by certified HVAC technician.

- The heating unit is approaching its designed life expectancy. We make no warranty, guarantee or estimation as to the remaining useful life of this unit.
- Furnace flame was observed to have pops of orange. This is a sign of a combustion problem. Recommend further evaluation by a licensed HVAC contractor.

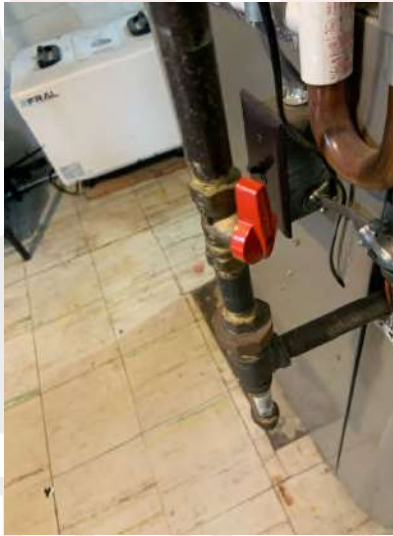
Observations:  
 • Gas shut off valves were present and appear to be functional at time of inspection.

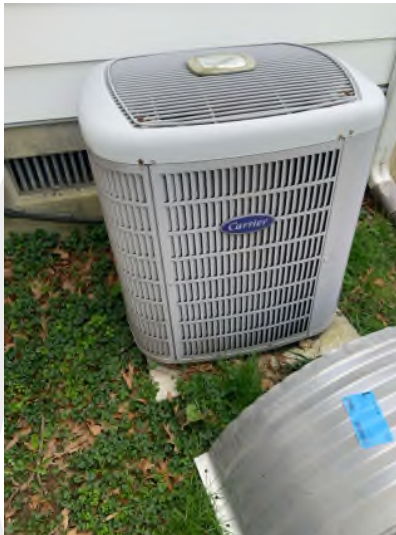
Compressor Type: electric  
 Location: The compressor is located on the exterior grounds.  
 Observations:  
 • Manufacture date: 2006  
 • With no recent service records observed, we recommend evaluation and service by a licensed HVAC contractor.  
 • Unit not tested in the cooling mode due to temperatures below 60°F in the past 24 hrs  
 • Annual HVAC service contract is recommended.  
 • The AC unit is approaching its designed life expectancy. We make no warranty, guarantee or estimation as to the remaining useful life of this unit.

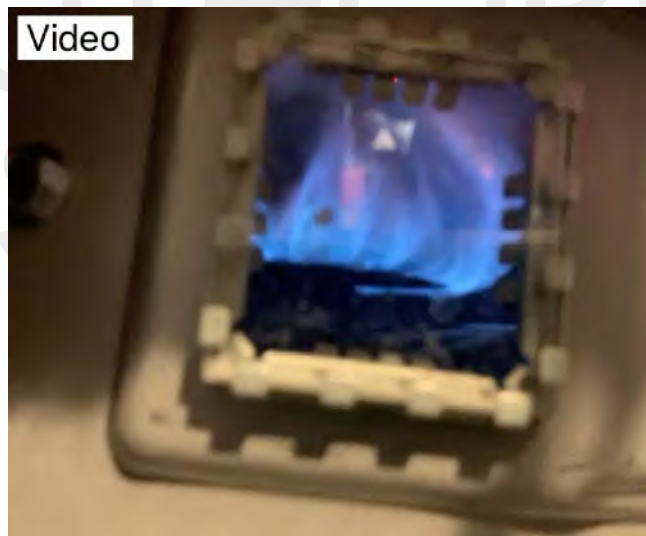
Observations:  
 • The combustion chamber is in functional condition.

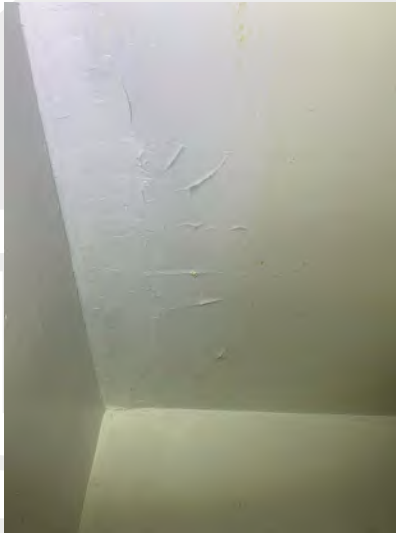
- Small cracking in the ceiling finish is noted. Recommend monitoring.

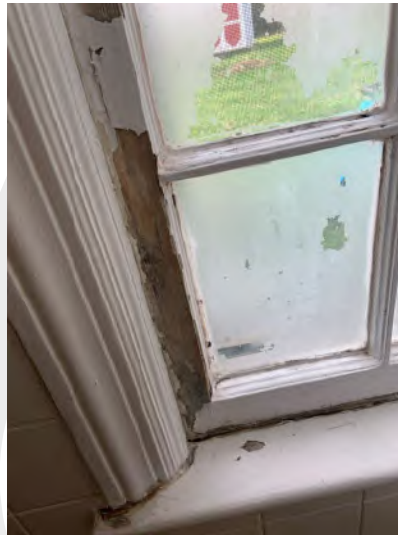
- Peeling paint observed, suggest scraping and painting as necessary.
- Windows noted appear to be painted closed. Recommend repair as necessary

REPAIRED

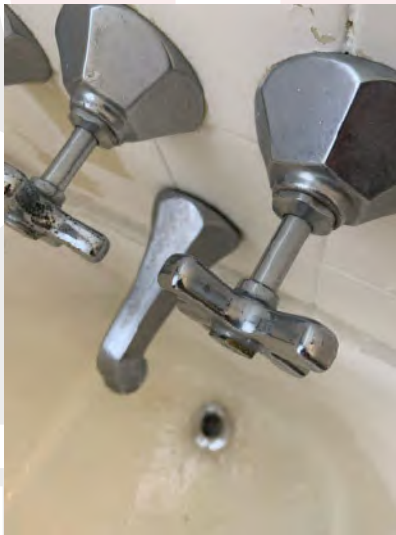
Observations:  
 • Faucet is not flush/sealed to the wall, which may result in water penetration to the interior structure and deterioration of the wall. Recommend repair as necessary.

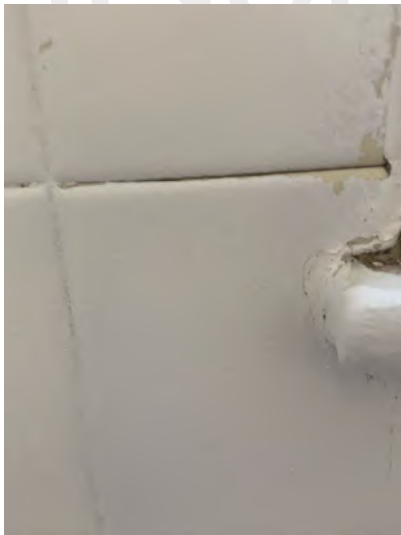
Observations:  
 • Ceramic tile noted.  
 • **\*\*OBSERVATIONS\*\***  
 • **Missing/damaged caulking/grout observed, recommend repair as necessary.**

**REPAIRED**

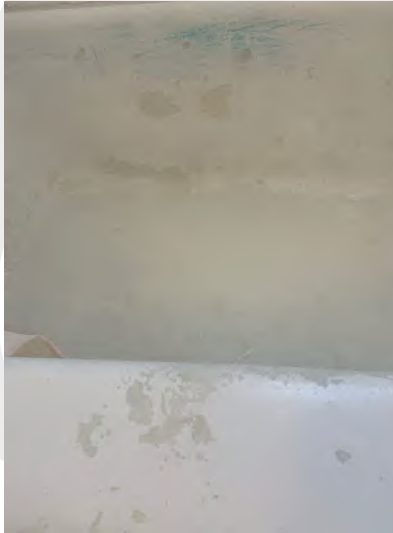
- Peeling observed, tub appears to have been refinished, suggest taking care when cleaning to protect the surface.

**REPAIRED**

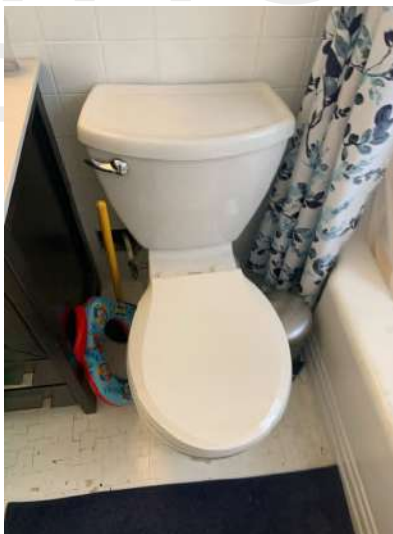
- The toilet bowl is loose at floor anchor bolts. The wax ring inside the unit must have a snug, secure fit in order to keep from leaking. Properly resealing and re-securing this unit is suggested to prevent water leakage and damage to the sub-floor area. This type of damage is not always visible or accessible to the inspector at time of inspection.

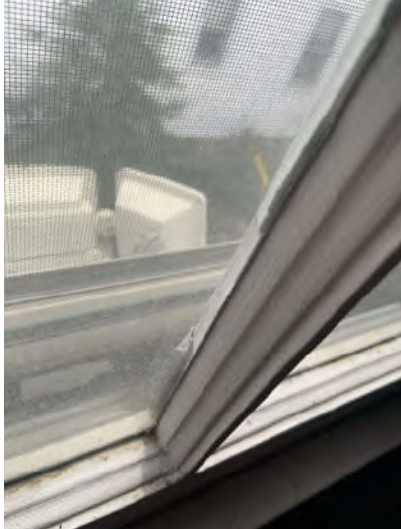
- Broken/cracked glass pane noted, repairs needed.
- Crumbling glazing observed, suggest re-glazing as necessary.

Glazing coming off when opening and closing

**REPAIRED**

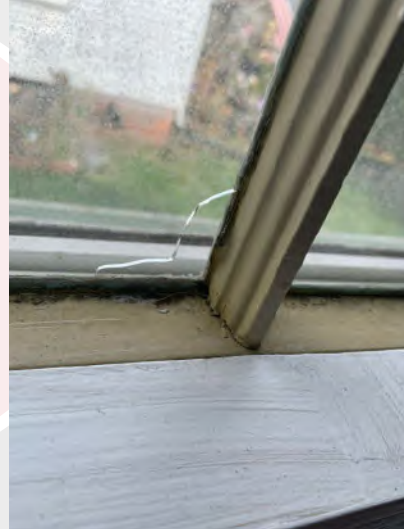
Front bed side window cracked glass

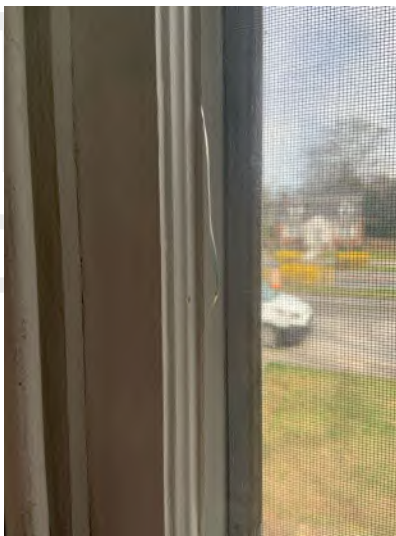
- Windows are original, older type. Consider upgrading to double pane, thermally insulated, newer efficient type.
- Broken/cracked glass pane noted, repairs needed.

Front window cracked glass

REPAIRED

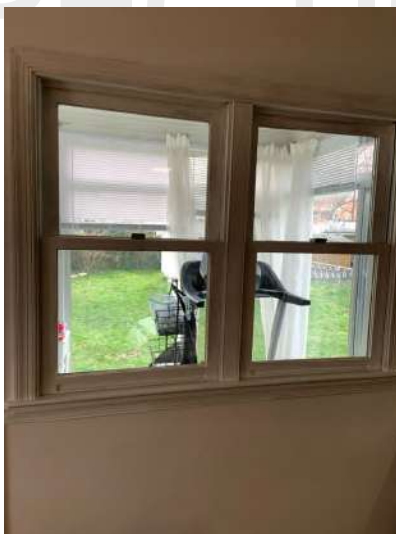
- Windows did not operate properly at one or more locations. Recommend review and repair as needed by qualified window contractors
- Windows noted appear to be painted closed. Recommend repair as necessary

Left window top pane paint shut / right window top and bottom panes slide down

**REPAIRED**

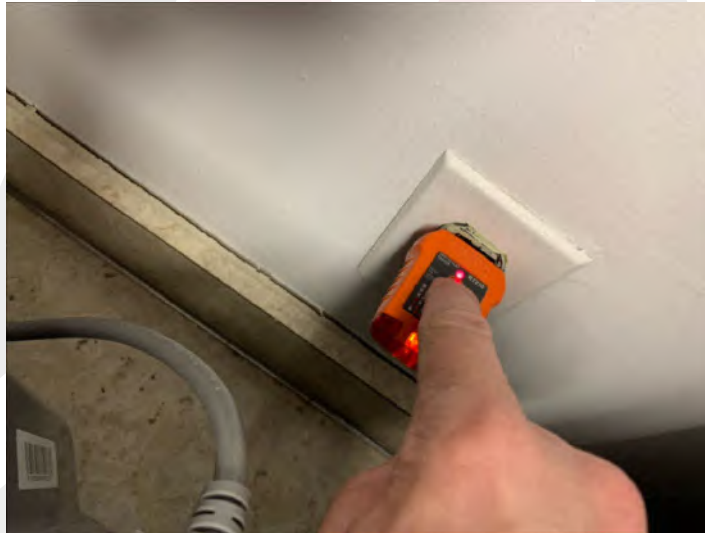
- No GFCI protection present, suggest installing GFCI protected receptacles for safety.

REPAIRED

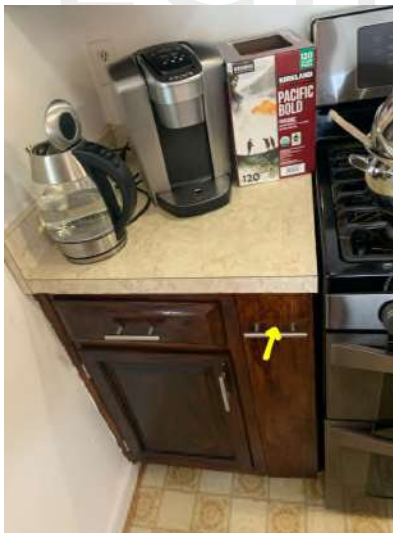
- Solid Surface tops noted.
- The counter tops are loose on the cabinet. We recommend having a qualified contractor re-fasten them.

REPAIRED

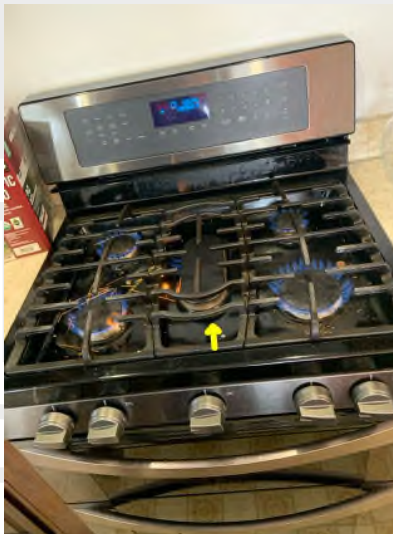
Observations:  
 • Oven: gas burners  
 • The burners did not operate properly when tested.

Middle burner not fully igniting

REPAIRED

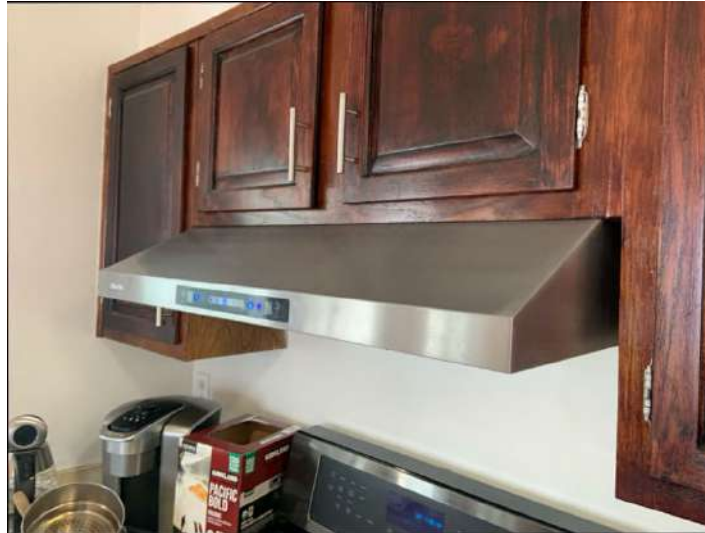
Observations:  
 • Functional at time of inspection although the vent is an exterior vent with no ductwork to the exterior.

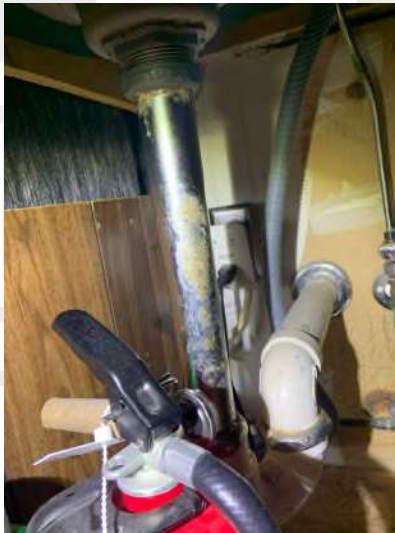
• Older style metal traps noted with corrosion. Buyer is cautioned that these traps can leak at any time due to corrosion.

REPAIRED

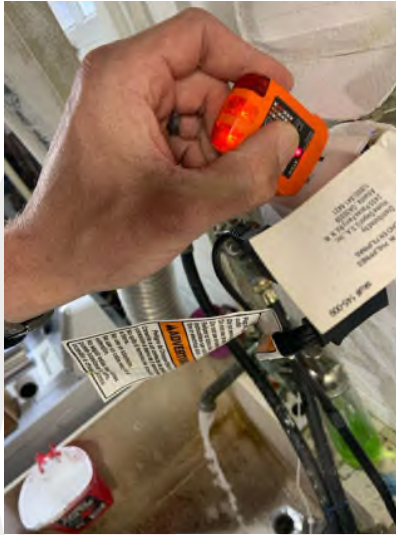
- No GFCI protection present, suggest installing GFCI protected receptacles for safety.

# REPAIRED

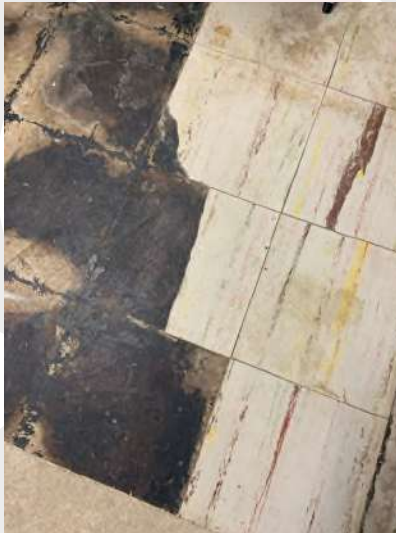
• Some of the floors in this building are a vintage 9x9 size; be advised that these tiles may be the type that had an adhesive containing asbestos. Asbestos is a health risk when it is made friable - in other words, when its fibres and dust can be breathed in by the lungs. To be safe, please refrain from removal and damaging these tiles until it is certain they are not asbestos containing material.

REPAIRED

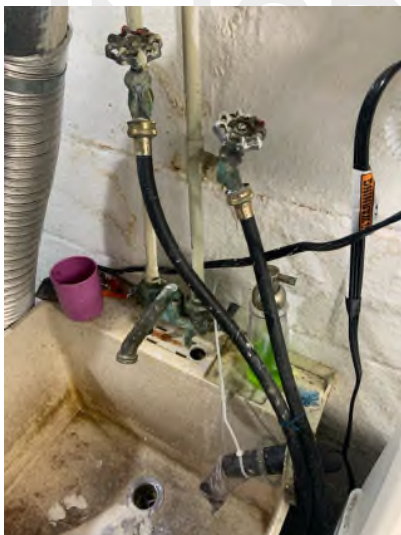
• Plumbing is loose on the wall. Recommend having secured to wall to prevent damage to supply line

Plumbing not secured to wall

REPAIRED

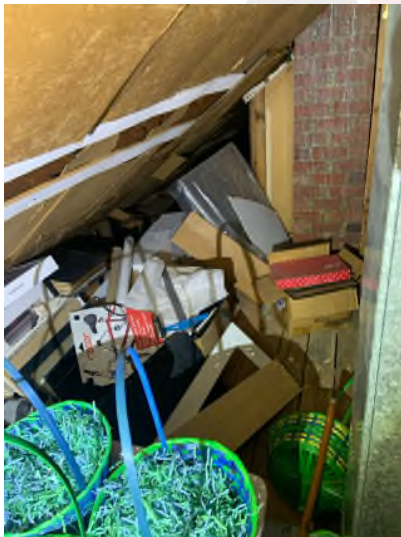
- No concerns with structure at time of inspection.
- Could not access all areas of the attic due to limited access.
- Stored personal items prevent complete attic inspection.
- Limited review due to insulation installed between the rafters.
- Evidence of past leaking noted. Recommend monitoring for future leaking and have evaluated by a licensed roofing contractor.

Stains

REPAIRED

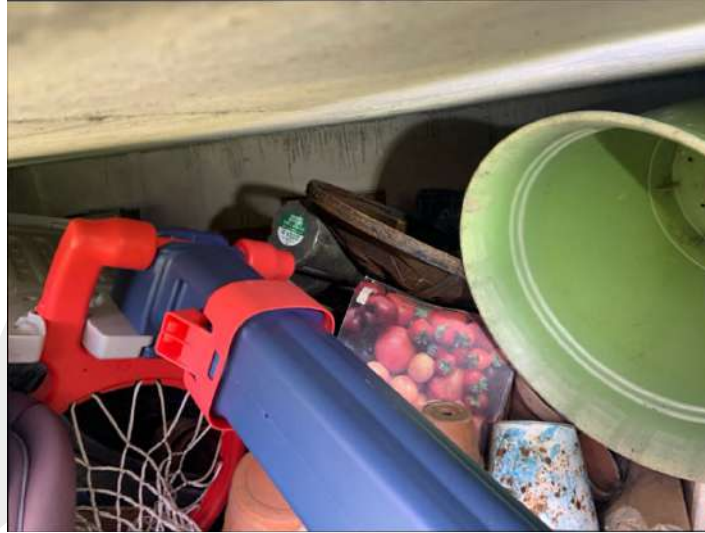
- Unable to access the sunrooms crawlspace at time of inspection due to too much personal items in way of access panel.

Unable to access sunroom crawlspace

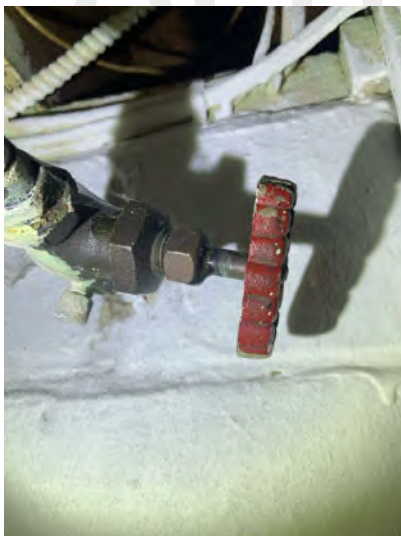
- Inspection of all areas of the drain and supply pipes was not possible due to limited access/finished walls and ceilings to check for defects such as, but not limited too:leaks, corrosion, improper workmanship, and damage.
- **\*\*WASTE\*\***
- No leaks observed at visible portions at time of inspection.
- Cast iron drain lines have a life expectancy of 60-75 years. Recommend budgeting for replacement, **BEFORE** leaks occur.
- **\*\*SUPPLY\*\***
- **Active leaking observed at water supply lines. Recommend evaluation by a licensed plumber for repair as necessary.**
- **There is corrosion/rust observed on some areas of plumbing. Recommend evaluation by a licensed plumber before leaks occur.**

Leaking valve above washing machine

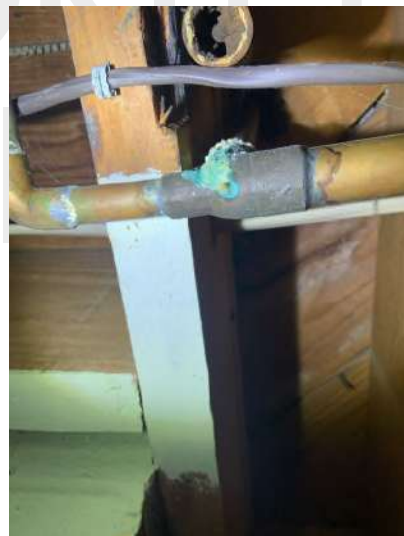
Corrosion

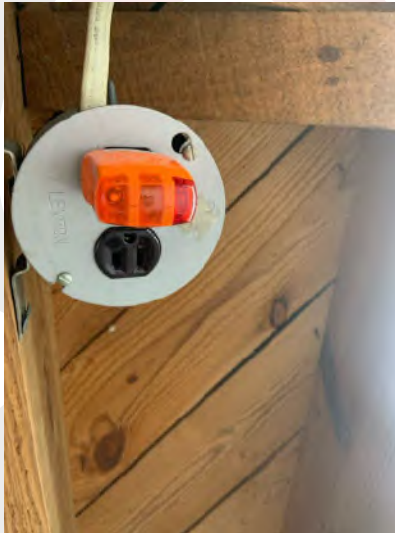
Observations:  
 • No power observed at one or more outlets. Recommend review by a licensed electrician.

Ceiling outlet not enough power

REPAIRED

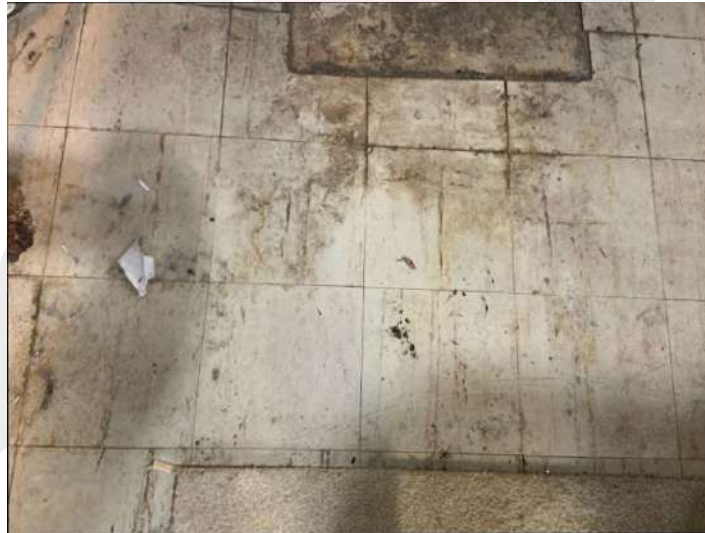
- Some of the floors in this building are a vintage 9x9 size; be advised that these tiles may be the type that contained asbestos or had an adhesive containing asbestos. Asbestos is a health risk when it is made friable - in other words, when its fibres and dust can be breathed in by the lungs. To be safe, please refrain from removal and damaging these tiles until it is certain they are not asbestos containing material.
